**IMPACT RESISTANCE OF
COMPOSITE FAN BLADES**

**PRATT & WHITNEY AIRCRAFT
DIVISION OF UNITED AIRCRAFT CORPORATION**

NATIONAL AERONAUTICS AND SPACE ADMINISTRATION

CONTRACT NAS3-16763

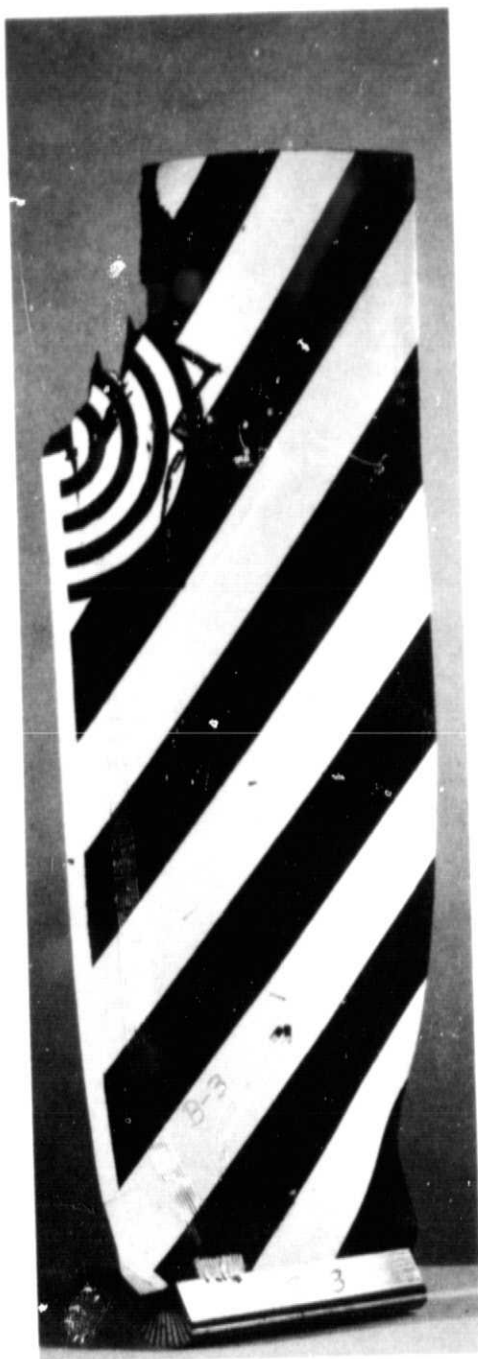
Figure 37 Boron/Epoxy Blade B-3 Following Impact with 165g Gelatin Ball

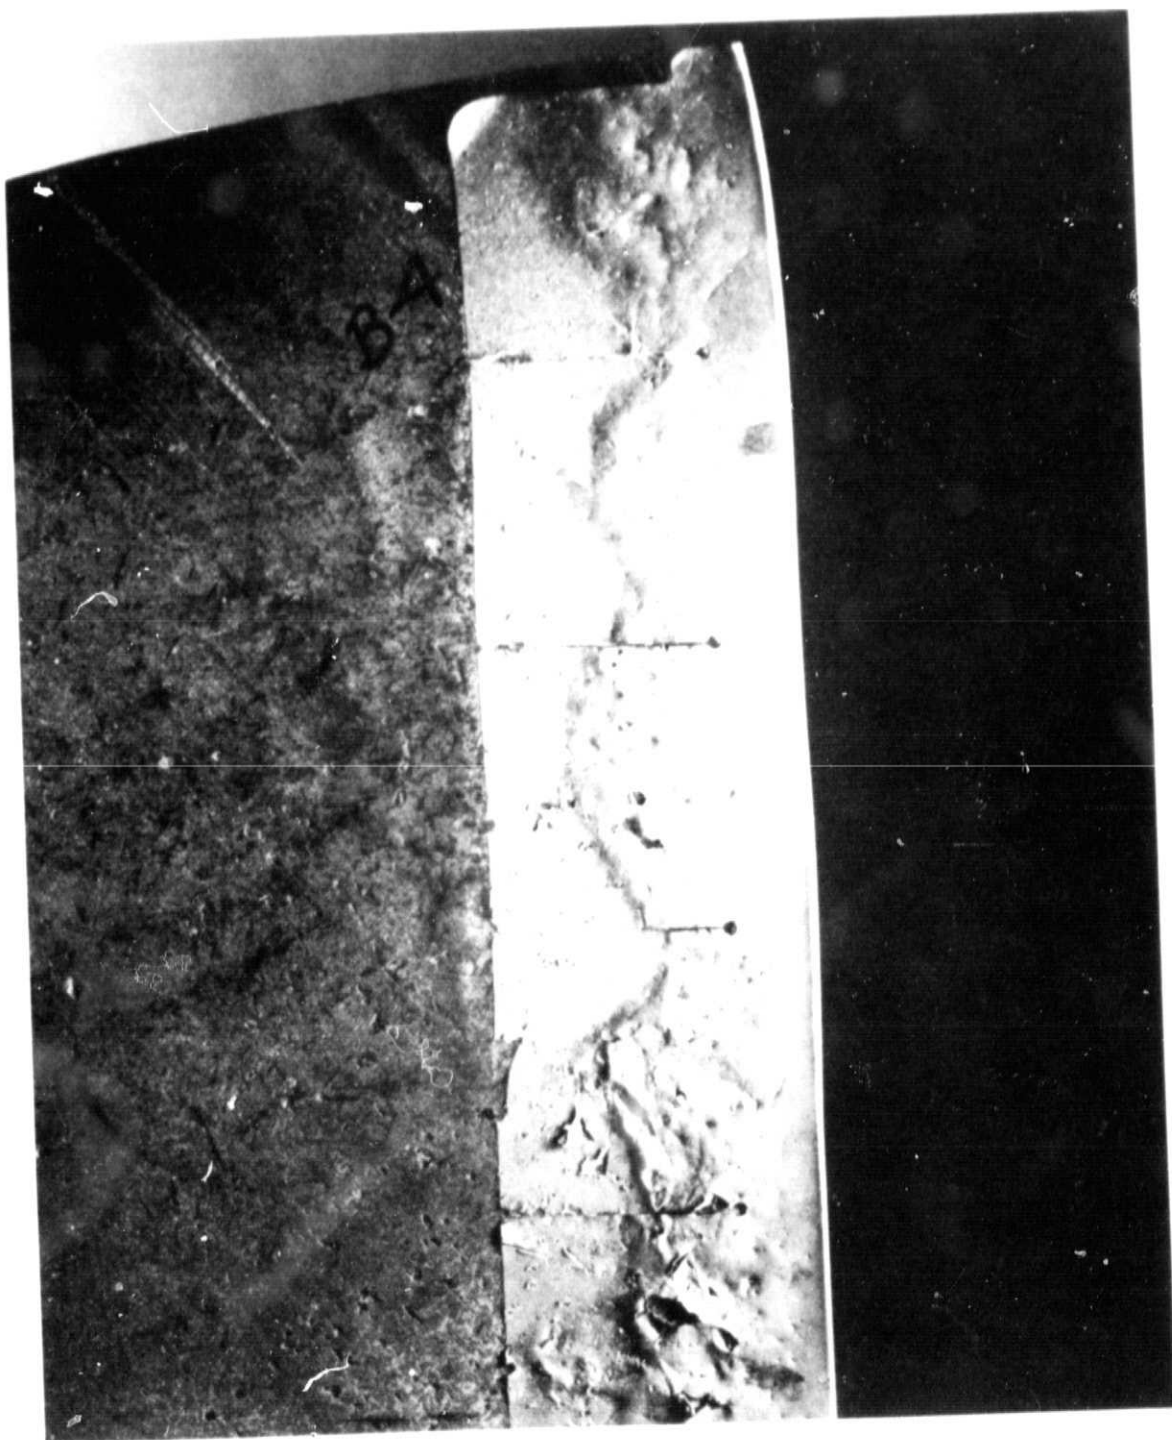
The gravel impact results on blade B-4 are shown in Figures 47 and 48. No ultrasonic indications were found after testing. Damage at the leading edge is negligible, even though the high-speed movies show that impacts did occur at this location. However, the concave side sheath, aft of the leading edge, was nicked, gouged, and unbounded, as pictured in Figure 49. The gravel apparently strikes the sheath causing compressive stresses on the sheath exterior surface. The stress differential within the sheath is great enough to break the sheath-to-blade bond and then lift the sheath from the surface of the blade. Therefore it is concluded that with a better bond between sheath and blade, the leading edge sheath could offer satisfactory protection from small amounts of gravel ingestion.

Figure 49 Boron/Epoxy Blade B-4 Following Impact with Gravel
